### **METHOD FOR CONSERVATION OF LATE 19<sup>TH</sup> CENTURY TIMBER FRAMED BUILDINGS IN ISTANBUL: POST-EARTHQUAKE HOUSE OF KEMALEDDIN EFENDI IN DOLMABAHCE PALACE**

**Damla Acar**

#### **Abstract**

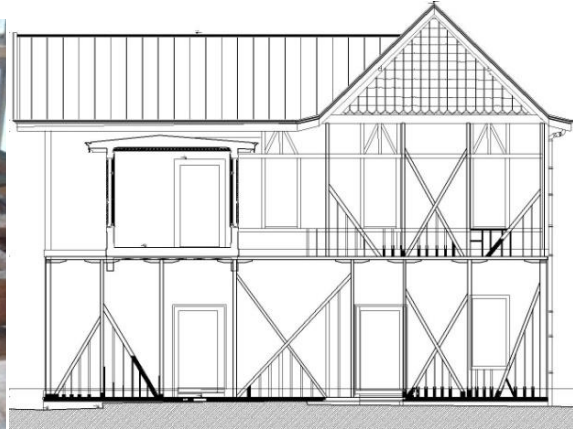
**Figure 8. Timber frame of the Northern wall**

The thick *English cement* plaster of the façade has protected the timber construction for 116 years. Except some posts and diagonals of the Northern wall, there was no decay in the timber elements that constitute the wall frame. The decay in the timber elements of the Northern wall was mainly due to the application of cement flooring in *taslik* space in 1966, which pushed the timber posts of the ground floor and caused out of plane behavior of Northern timber wall and deformation of the façade plaster. The rain entered the wall through the edges and micro cracks of the deformed plaster and caused the decay of timber elements.

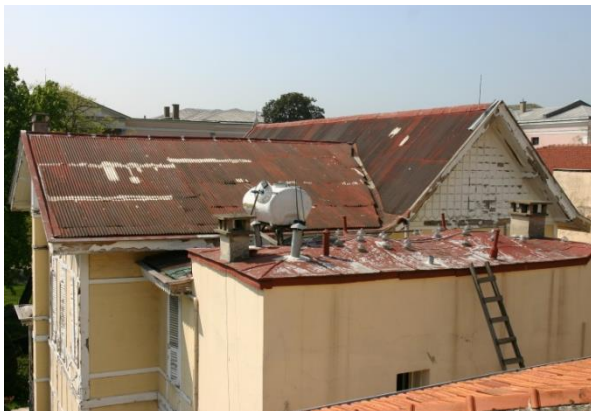
The roof covered with corrugated galvanized sheets was leaking water and caused damage to some of the painted ceiling canvases. The leakage originated from the inappropriate detailing of galvanized sheets during the 1985 intervention. Instead of using screws, as shown in Figure 13, nails were used to fix the covering sheets. Moreover, galvanized sheet has an average life of 15-20 years, but it was used for 26 years without any maintenance (Figure 17). The ventilation funnels (Figure 18) helped the drying of the timber roof structure, except the very end parts of the beams that were boxed in the eaves.

**Figure 17. The condition of the corrugated galvanized sheets**

The roof structure was designed to bear the weight of the galvanized sheets, which were the original covering materials. However, the difficulty in their application and short average life brings forward the consideration of modern roof covering materials (i.e. titanium zinc sheets), which should be as light as galvanized sheets, but with longer average life.

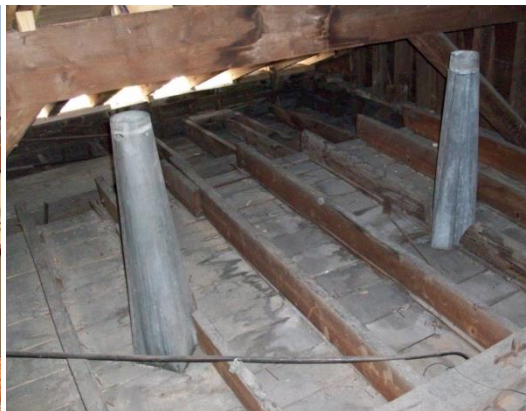
**Figure 18. Ventilation funnels inside the roof**

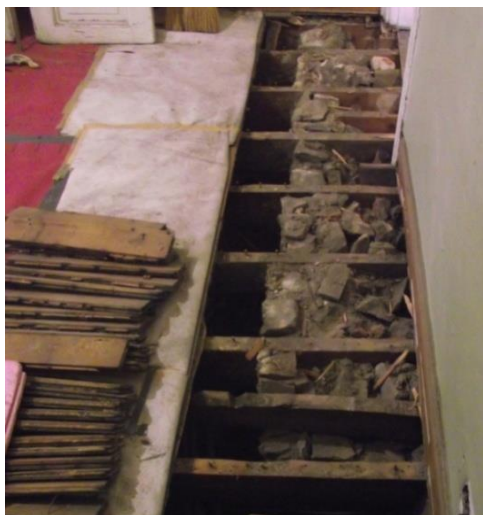
The decay of the timber structural elements was mostly observed above the masonry foundation wall. Almost the entire base beam decayed and the end parts of ground floor beams, posts and diagonals resting on the base beam were affected as well. The reason for this decay was the rubble fill inserted over the foundation wall between the floor beams, which prevented the ventilation of the base beam and floor beams (Figure 19 and 20).

**Figure 19. Floor beams embedded into the rubble fill**  
Source: Acar (2013e)

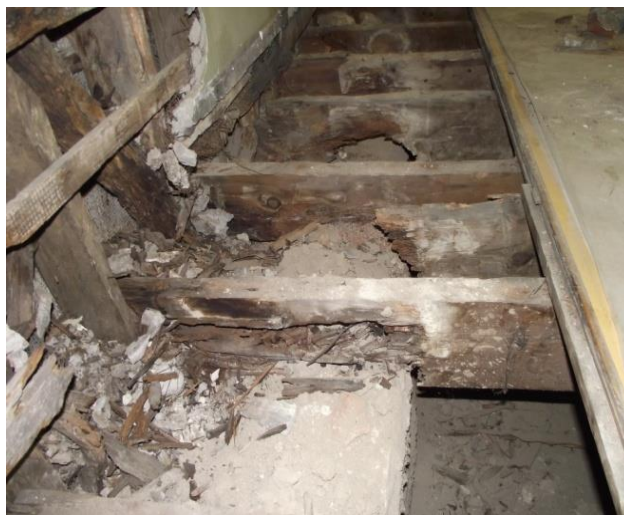
**Figure 20. The decay in the floor beams observed after the removal of the rubble fill**  
Source: Acar (2013f)

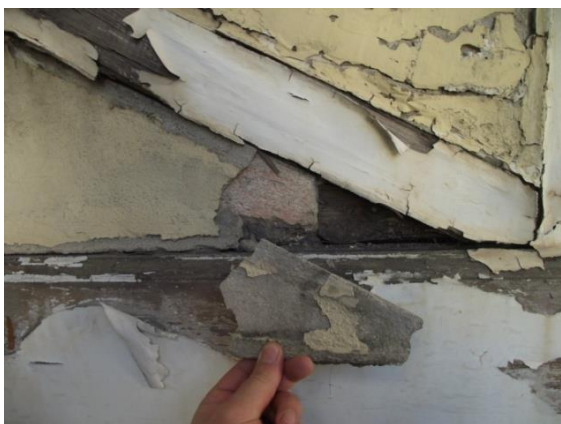
The damaged Northern façade plaster was repaired in 1966 and 1985 using modern Portland cement applied directly on the original *English cement* layer (Figure 21). This inappropriate intervention fastened the deterioration of the façade plaster and the timber structure behind the plaster. The modern Portland cement plaster should be cleaned out from the Northern façade and the damaged parts of *English cement plaster* should be restored with compatible plaster prepared in accordance with 19<sup>th</sup> century cement.

**Figure 21. Modern Portland cement applied on the 19<sup>th</sup> century cement plaster**  
Source: Acar (2014c)

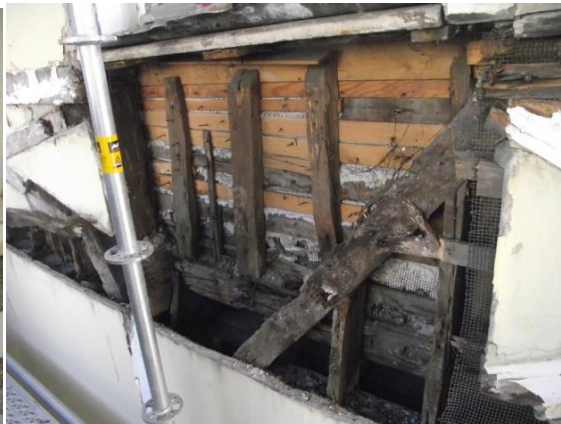
**Figure 22. Bagdadi wooden laths nailed on the timber posts during 1966 or 1985 repair**  
Source: Acar (2014d)

Istanbul timber houses of the 19<sup>th</sup> century have been depicted as buildings with traditionally (hand) shaped timber frame with *bağdadi* wall plaster (wooden laths nailed on the timber construction and *horasan* mortar applied) on the inside and timber planks as façade covering. That was the prevailing building technique in many neighborhoods in the city throughout 19<sup>th</sup> century. However, industrial products that dominated the Ottoman market in the late 19<sup>th</sup> century affected timber construction technique as well. Cement façade plasters were seen as solution for fire protection, while corrugated galvanized sheets were preferred as lighter, cheaper and faster applied covering materials. The Ottoman contracts and cost estimates prepared in the last decades of the 19<sup>th</sup> century refer to the use of mainly six cement types; English Johnson cement, English Hollich cement, Grenoble cement, Capa cement, Roquefort cement and Portlan (d) cement (BOA, 1894a and 1893). It is difficult to identify these cements only by chemical analyses, since there is no databank for 19<sup>th</sup> century cement plasters and mortars in material laboratories. These materials are simply classified according to their color or sometimes even named as Portland cement, which brought the danger of considering them as inappropriate interventions. Thus, mostly cement plasters have been removed and replaced with *horasan* mortar during restorations. One way to detect the authenticity of cement plasters and mortars are Ottoman cost estimates. These cost estimates can also be used as reference data while creating a databank for cement types used in the 19<sup>th</sup> century Istanbul. The presence of galvanized wire in traditional timber buildings is also considered as modern intervention and it is easily replaced with *bagdadi* laths. That was the case in partial repairs done in the Northern wall of Kemaleddin Efendi house during 1966 or 1985 restorations (Figure 22).
