### **METHOD FOR CONSERVATION OF LATE 19<sup>TH</sup> CENTURY TIMBER FRAMED BUILDINGS IN ISTANBUL: POST-EARTHQUAKE HOUSE OF KEMALEDDIN EFENDI IN DOLMABAHCE PALACE**

**Damla Acar**

#### **Abstract**

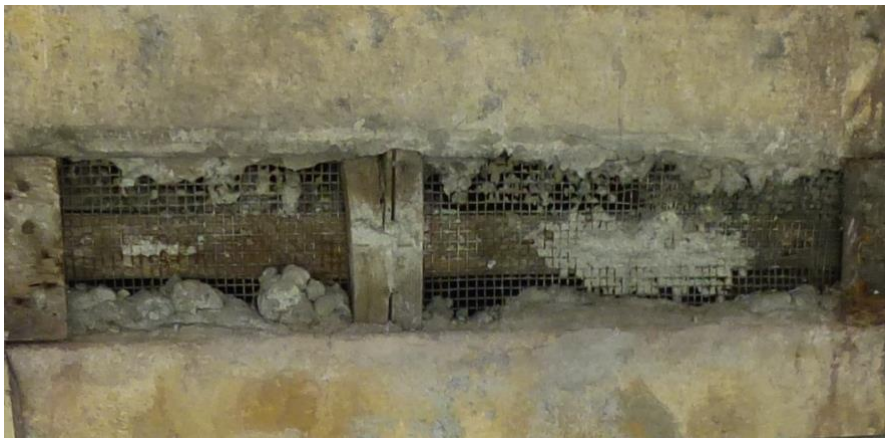
The wooden wall structure is covered with galvanized wire both inside and outside. Serkiz's cost estimate reveal that *English cement* plaster was applied on the galvanized wire of the façade, which was very common for the timber buildings constructed during Sultan Abdulhamid II's period (Acar and Mazlum, 2016). After Abdulhamid II settled in Yıldız Palace in 1878 and started the construction of his residence buildings, he preferred timber construction as the cheapest and fastest building technology. However, he was aware that timber construction was not resistant to fire. Due to the industrial developments and new materials of the 19<sup>th</sup> century, cheaper and faster technique for fire protection of timber buildings was adopted. The outer façades of the timber buildings constructed within the boundaries of Yıldız Palace were finished with thick *English (Johnson) cement* plaster. Galvanized wire was nailed to the timber construction and 2-3 cm thick cement plaster was applied over the wire (Figure 9). Ottoman cost estimates reveal that especially after 1880s, timber constructions with *English (Johnson) cement* plaster were predominantly applied for building, repairing or enlarging residential buildings of imperial family or high bureaucracy. Almost all of the timber houses constructed after 1894 Istanbul earthquake had the same *English cement* plaster on the façade (Acar and Mazlum, 2016).

The laboratory analyses report of the 2-3 cm thick façade plaster of Kemaleddin Efendi house concludes that this plaster which binder is *Portland cement* with 350-400 cement factor has 20-25% areal binder ratio. The façade plaster contains only sand as aggregate and very few amounts of brick ballast and black slag (Istanbul Metropolitan Municipality, KUDEB, 2011) (Figure 9). The cement factor of the façade plaster shows that it was prepared as strong as artificial stone. The laboratory analyses of façade cement plaster interpret the binder as *Portland cement*, which is probably "*English (Johnson) cement*" mentioned in the cost estimate. *Portland cement* plaster was also used in the 19<sup>th</sup> century Istanbul buildings, and if so, it was clearly stated in the cost estimates and recorded as *Portlan(d) cement* (BOA, 1894a).

**Figure 9. Galvanized wire and 2-3 cm thick *English cement* plaster on the outer façade of Kemaleddin Efendi timber house**  
Source: Acar (2013d)

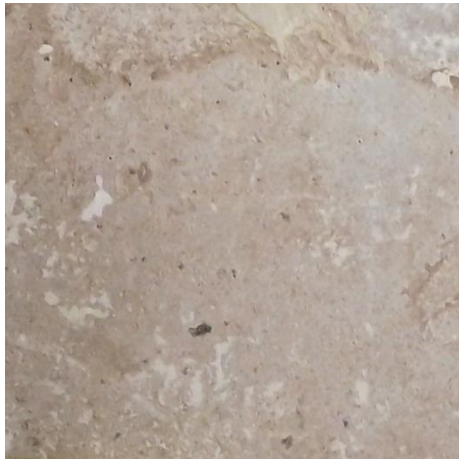
There are two different plasters on galvanized wire of the inner walls, *English cement* plaster covers ground floor walls and "*local fine gypsum*" (*ince yerli alçı*) plaster covers the upper floor inner walls of the house. "*Local fine gypsum*" plaster applied 2 cm thick on the galvanized wire was recorded in the second cost estimate prepared by Serkiz Balyan on 18 September 1894 (BOA, 1894e). The SEM-EDS analyses reveal the composition of that plaster (Figure 10b-11a and 11b). The analyses report states that inner wall plaster has 2 units of gypsum and 1 unit of "*19<sup>th</sup> century cement*" as a binder (Istanbul Metropolitan Municipality, KUDEB, 2011). The sample

The inner wall gypsum cement and *English cement* plasters of Kemaleddin Efendi house differ in appearance. *English cement* plaster has a rough surface; whereas gypsum based cement plaster is very smooth (Figure 10a). It was surprising that the decorative painting was detected on the rough *English cement* and not on the smooth gypsum plaster (Figure 12). The reason for that was a great mystery until handmade wallpaper pieces were discovered inside the timber roof of the veranda (Figure 13). The wallpaper was probably covering the smooth gypsum based cement walls of the upper floor.

**Figure 10a. Photograph of the gypsum based cement plaster**

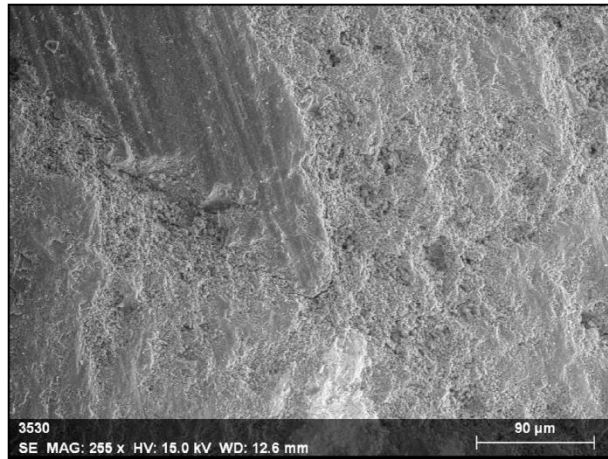
**Figure 10b. SEM image of the gypsum based cement plaster**

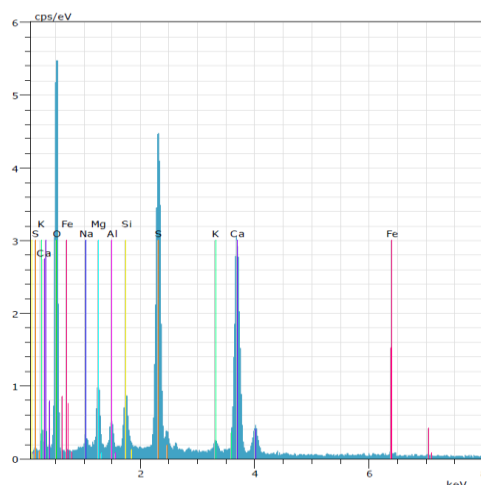
**Figure 11a. XRD pattern of gypsum based cement plaster**

**Figure 11b. Elemental composition of gypsum based cement plaster**

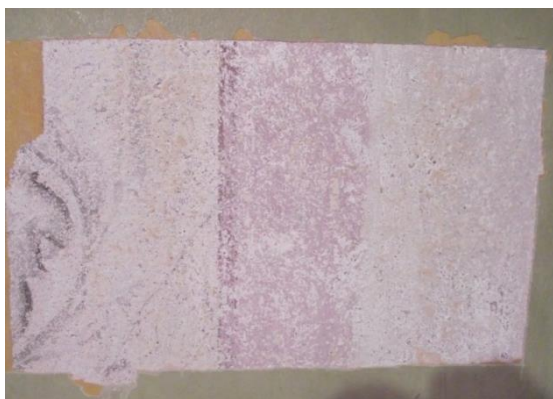
**Figure 12. Water based decorative paint on the English cement plaster of the inner wall of Kemaleddin Efendi house**

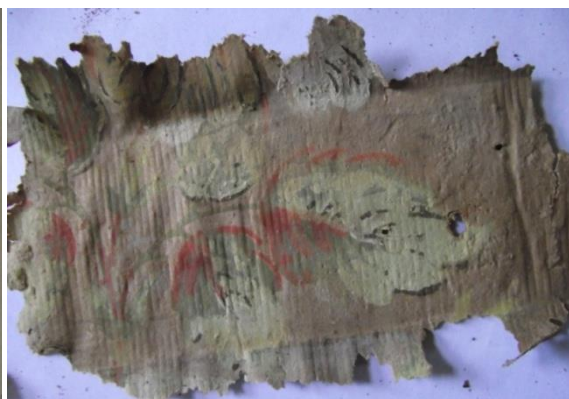
**Figure 13. Piece of handmade wall paper**

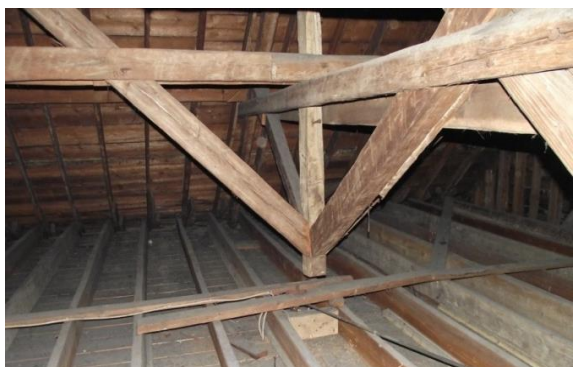
Timber frame elements of the house's roof (trusses, posts, purlins, ridgepole and diagonals) are all original (Figure 14). The posts and trusses are oak, while the purlins and ridgepole are pine from Filyoz Region (Southern Black Sea) (BOA, 1894c). Over the timber covering planks tar-impregnated felt was laid out and corrugated galvanized sheets were put over that felt and screwed to the timber planks (BOA, 1894c) (Figure 15). This roof covering technique was often used in the last decades of the 19<sup>th</sup> century, and could be traced through many cost estimates of the period. One of those cost estimates prepared in 1890 concerning the roof repair of masonry Maslak Kiosk, mentions the replacement of tile roof coverings with corrugated galvanized sheets (BOA, 1890). Similar to Kemaleddin Efendi's house, almost all of the 19<sup>th</sup> century post-earthquake timber houses were covered with corrugated galvanized sheets, which were 1.5 mm thick and weighting 11.78 kg/m<sup>2</sup>. Whereas, Marseille tiles used in the 19<sup>th</sup> century weight 42.5 kg/m<sup>2</sup> and 1.5 mm thick lead sheets weight 17.10 kg/m<sup>2</sup>. Thus, the industrial products of the 19<sup>th</sup> century made possible the lightening of roof, which enabled earthquake safe constructions.

**Figure 14. Timber roof structure**  
Source: Acar (2012c)

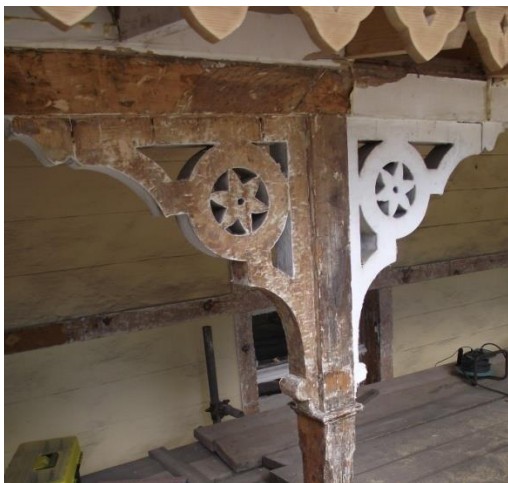
The literature on the late 19<sup>th</sup> century construction techniques in Ottoman Empire emphasize that masonry construction techniques evolved and standardized with the production of artificial stone and cement plasters (Baturayoglu Yoney and Ersen, 2009). Whereas, timber buildings are not discussed as rationalized constructions and it is even accepted that they were neglected or even forbidden with the 1848, 1863 and 1875 Building Regulations. However, archival sources reveal that timber framed residences were preferred by the imperial family members or bureaucrats especially after 1880s and those were characterized with the presence of factory produced timber elements. The timber decorative elements of the veranda (Figure 23) and wooden laths on the ceilings were factory produced (machine shaped) elements of Kemaleddin Efendi house that survived until today. It could be concluded from the cost estimates that the intention of Serkiz Balyan was to build the entire timber frame of the house with standardized factory shaped elements, but the material shortage after the earthquake forced him to build the timber frame in traditional technique. Whereas, the post-earthquake houses within the boundaries of Yıldız Palace were built with standardized factory shaped timber elements (Acar and Mazlum, 2016) (Figure 7). Moreover, after the establishment of Ahirkapi Timber Factory in 1893, Victorian or *chalet* type fully prefabricated timber houses became fashionable as summer residences of bureaucrats or tradesmen (Ahmed Ihsan, 1899) (Figure 24). Thus, the restorations of 19<sup>th</sup> century timber houses do not necessarily mean dealing with the traditional building techniques, details and materials.

**Figure 23. Wooden moulding shaped with saw machine in 1894**
